Wellhead Annulus Inspection – Case Study

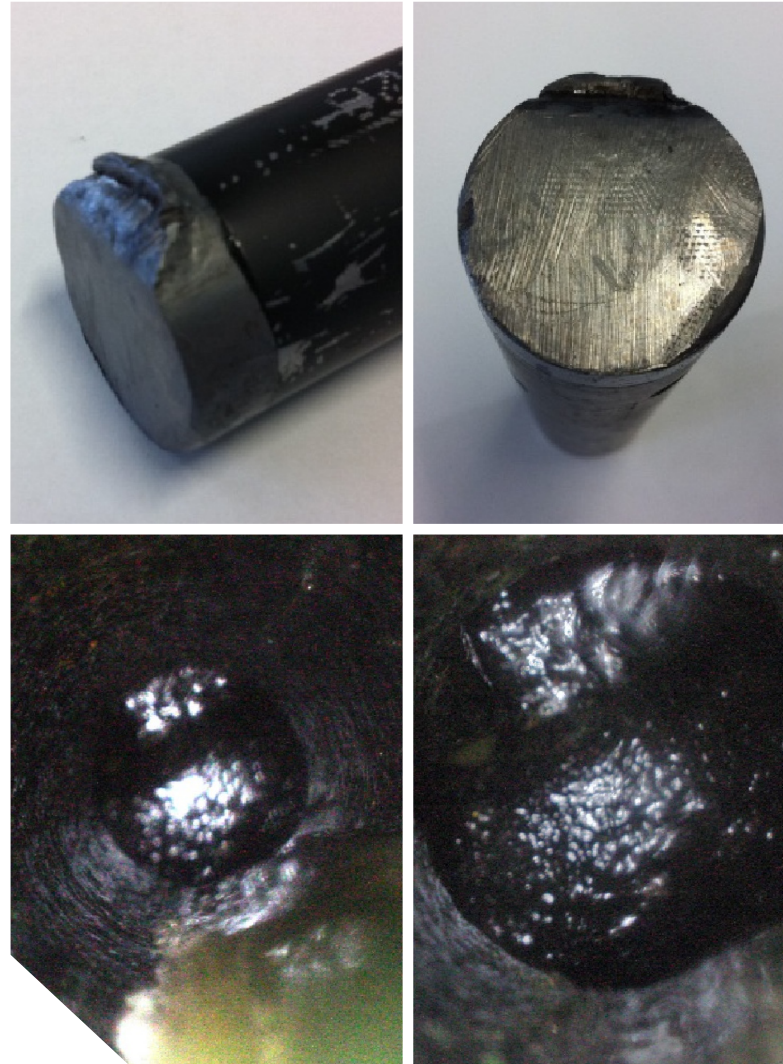
A lead impression block was run in through the annulus wing valves to determine the condition of the annulus entry port in the wellhead. Two runs were carried out; the first did not seem to reach the annulus because the LIB was retrieved unmarked. On the second run, the LIB was removed with scarring to the topside (see opposite) from impact with a lip or restriction.

The LIB run was followed by 2 camera runs. Following review of the footage varying degrees of wellbore clean up were carried out (flushing, soaking with diesel) to provide the best indication of the condition of the inside of the annulus, the annulus valves and the internal threads in the wellhead. For the final runs, Nitrogen was used to provide a buffer to keep the wellhead fluids in check. The results showed clear footage of the condition of the annulus port, the expected lip on the top side and the absence of threads on the inside of the wellhead body.
