Wellhead Annulus Inspection – Case Study

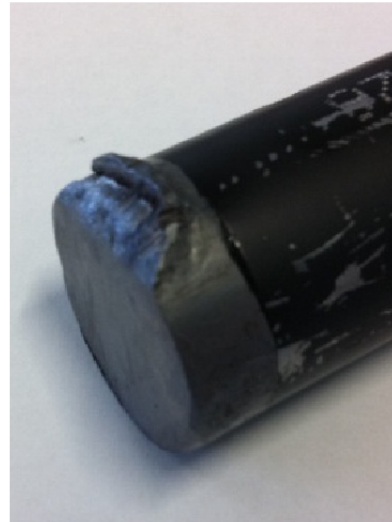
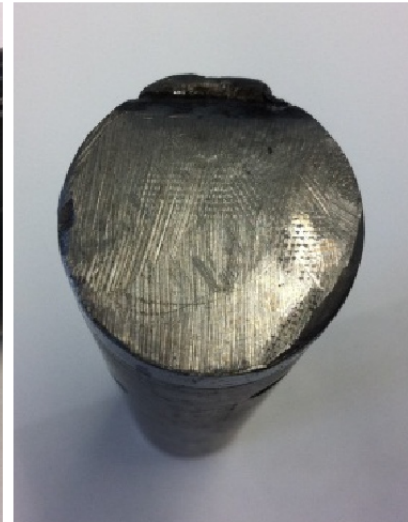
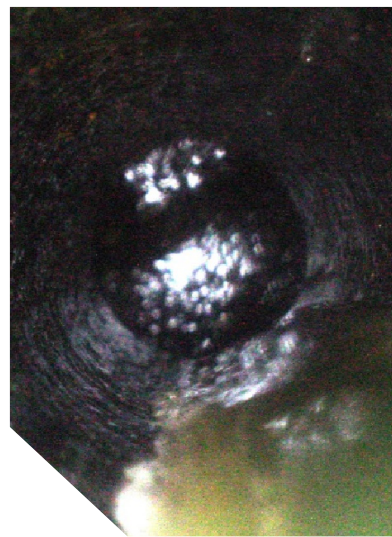
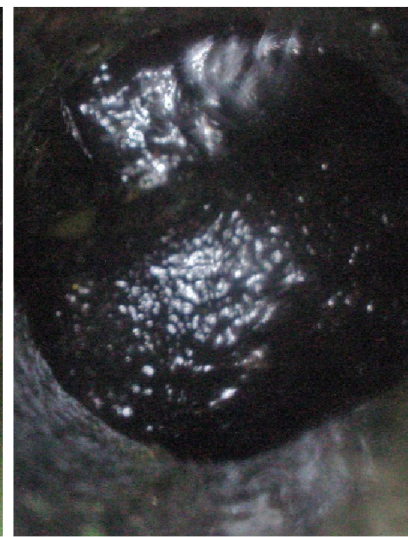
A lead impression block was run in through the annulus wing valves to determine the condition of the annulus entry port in the wellhead. Two runs were carried out; the first did not seem to reach the annulus because the LIB was retrieved unmarked. On the second run, the LIB was removed with scarring to the topside (see opposite) from impact with a lip or restriction.

The LIB run was followed by 2 camera runs. Following review of the footage varying degrees of wellbore clean up were carried out (flushing, soaking with diesel) to provide the best indication of the condition of the inside of the annulus, the annulus valves and the internal threads in the wellhead. For the final runs, Nitrogen was used to provide a buffer to keep the wellhead fluids in check. The results showed clear footage of the condition of the annulus port, the expected lip on the top side and the absence of threads on the inside of the wellhead body.
