## RestrictionVA

# DIAGNOSING WELLBORE ACCESS PROBLEMS

Combined with EV's Visual Analytics, the Memory HD Camera offers an efficient and definitive method to identify the root cause of restricted wellbore access

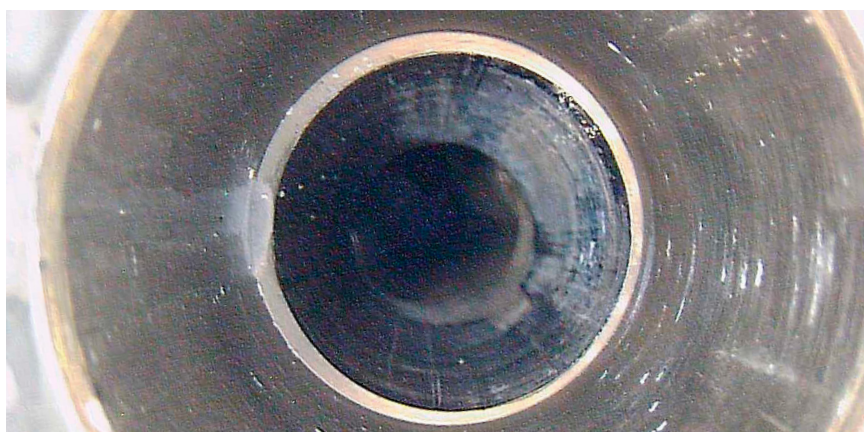
Figure 1: Step decrease in ID at pup joint and impact marks on low side

The first issue was found to be an unexpected change in diameter in the upper part of the assembly. Impact marks on the low side of the wellbore indicate where the drift tools have contacted restriction. (**Figure 1**) With the side pocket mandrel found to be oriented at low-side (**Figure 2**), it became clear that it was not possible to secure safe passage for the perforating guns. Armed with the definitive, quantified information provided by EV's RestrictionVA service, the operator decided to defer activity on the well until a work-over unit was available to complete the perforating operation with the upper completion removed.

Images from the Optis® M125 camera clearly show the hold-up depth of the first slickline runs (**Figure 1**). The root cause of the shallow holdup is determined to be an apparent, but unexpected, step change in pipe diameter at a pup joint. Impact marks on the low side of the wellbore indicate where the toolstring movement has been restricted due a combination of a wellbore ID change and deviation.

Armed with the definitive, quantified information provided by EV's RestrictionVA service, the operator decided to defer activity on the well until a work-over unit was available to complete the perforating operation with the upper completion removed.

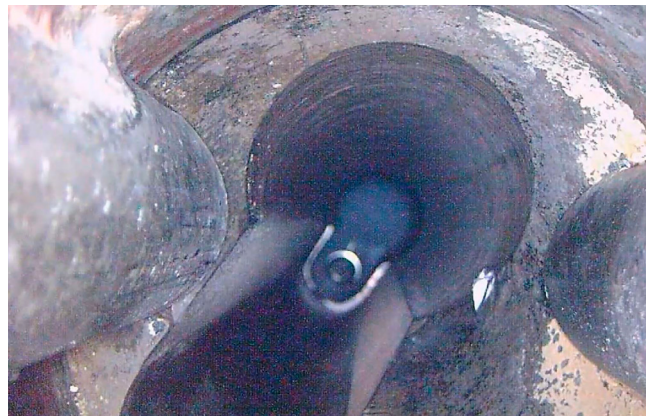
Slickline runs of reduced diameter and varied design succeeded in passing the pup joint, seen in Figure 1, only for progress to be halted at a side pocket mandrel (SPM) just below. Figure 2 shows a impact damage at the SPM which is most likely due to tool impact. Figure 3 also shows the condition and orientation of the gas lift valve and mandrel. With the pocket found to be oriented at low-side, and seeing the impact marks from the previous drift runs, it became clear that it was not possible to secure safe passage for the perforating guns.

Figure 2: Impact damage identified from tool impact at SPM

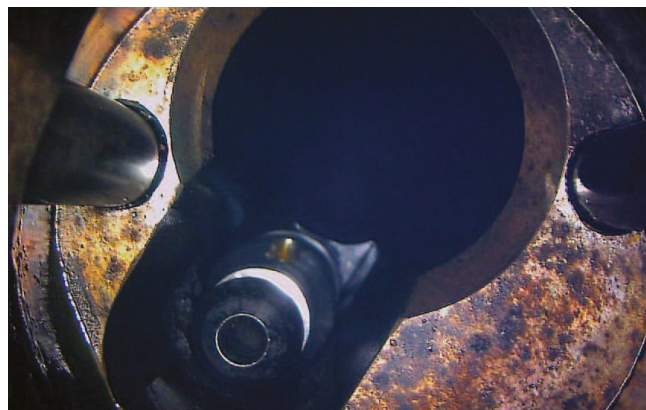
Figure 3: Condition and orientation of GLV and SPM (low-side)

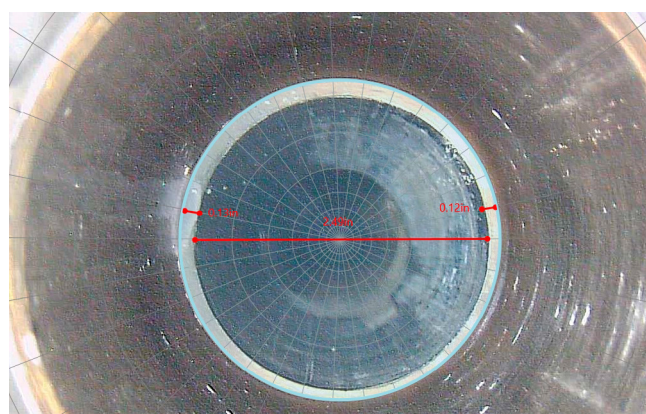
EV's integrated visualisation and dimensioning software enabled accurate in-situ measurements of the inner diameter of the pup joint and the step change in diameter encountered by the drift tool strings. (**Figure 4**). These measurements provided the customer a more detailed understanding of the restriction and further evidence to support why certain drift designs would not pass this point.

Figure 4: EV's Dimensioning software used to measure an unexpected reduction in ID at a pup joint
