RestrictionVA

DIAGNOSING WELLBORE ACCESS PROBLEMS

Combined with EV's Visual Analytics, the Memory HD Camera offers an efficient and definitive method to identify the root cause of restricted wellbore access

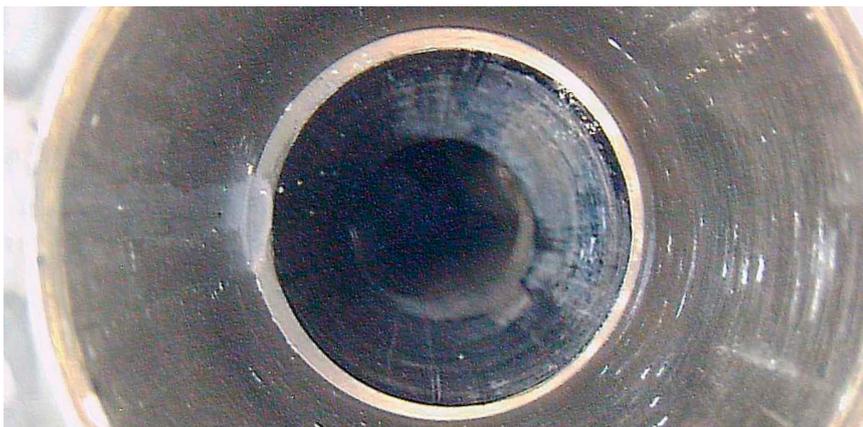
Figure 1: Step decrease in ID at pup joint and impact marks on low side

The first issue was found to be an unexpected change in diameter in the upper part of the assembly. Impact marks on the low side of the wellbore indicate where the drift tools have contacted restriction. (**Figure 1**) With the side pocket mandrel found to be oriented at low-side (**Figure 2**), it became clear that it was not possible to secure safe passage for the perforating guns. Armed with the definitive, quantified information provided by EV's RestrictionVA service, the operator decided to defer activity on the well until a work-over unit was available to complete the perforating operation with the upper completion removed.

Images from the Optis® M125 camera clearly show the hold-up depth of the first slickline runs (**Figure 1**). The root cause of the shallow holdup is determined to be an apparent, but unexpected, step change in pipe diameter at a pup joint. Impact marks on the low side of the wellbore indicate where the toolstring movement has been restricted due a combination of a wellbore ID change and deviation.

Armed with the definitive, quantified information provided by EV's RestrictionVA service, the operator decided to defer activity on the well until a work-over unit was available to complete the perforating operation with the upper completion removed.

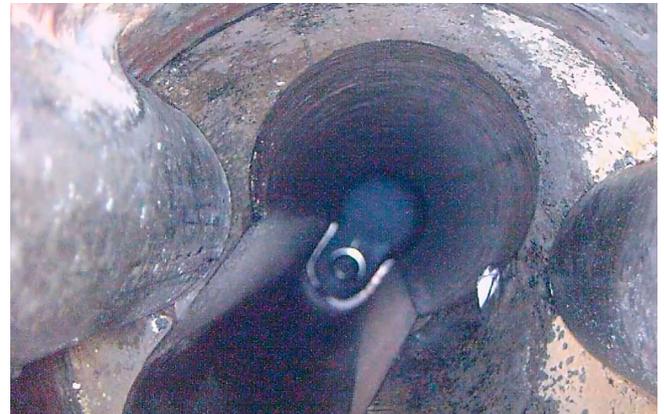
Slickline runs of reduced diameter and varied design succeeded in passing the pup joint, seen in Figure 1, only for progress to be halted at a side pocket mandrel (SPM) just below. Figure 2 shows a impact damage at the SPM which is most likely due to tool impact. Figure 3 also shows the condition and orientation of the gas lift valve and mandrel. With the pocket found to be oriented at low-side, and seeing the impact marks from the previous drift runs, it became clear that it was not possible to secure safe passage for the perforating guns.

Figure 2: Impact damage identified from tool impact at SPM

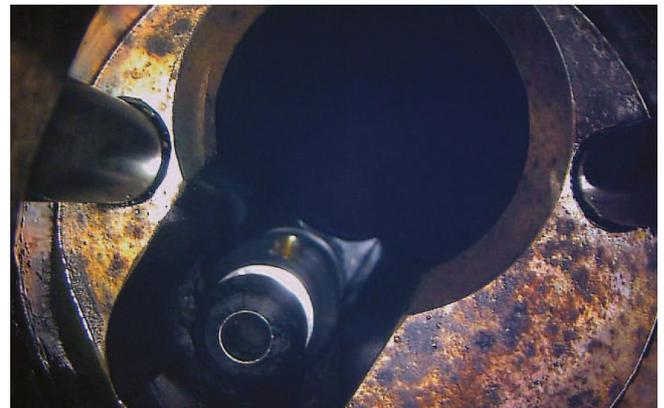
Figure 3: Condition and orientation of GLV and SPM (low-side)

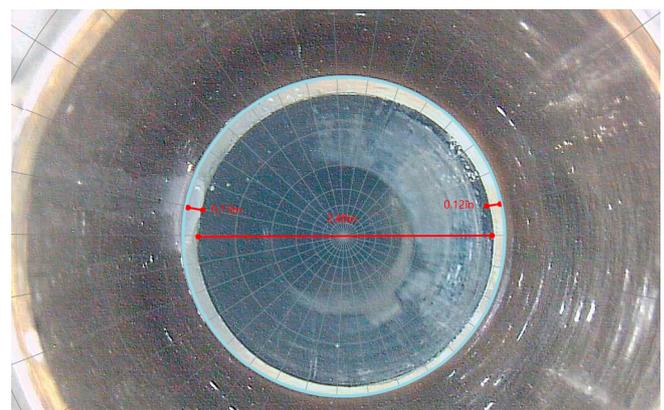
EV's integrated visualisation and dimensioning software enabled accurate in-situ measurements of the inner diameter of the pup joint and the step change in diameter encountered by the drift tool strings. (**Figure 4**). These measurements provided the customer a more detailed understanding of the restriction and further evidence to support why certain drift designs would not pass this point.

Figure 4: EV's Dimensioning software used to measure an unexpected reduction in ID at a pup joint
