## PerforationVA

# OPTIMIZING PERFORATION PRODUCTIVITY

EV's Optis Infinity Hybrid provides a complete 360° image of the well while substantially reducing operating time and cost

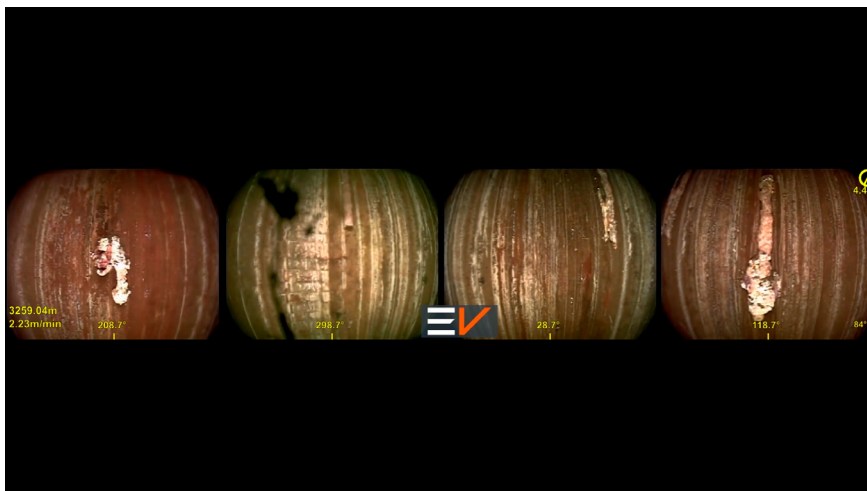
The camera was run in hole to a depth of 3200m, where the detailed real-time video footage confirmed the presence of salts across all of the perforated intervals. The 360-degree perspective provided by the four sideview cameras revealed the condition of each perforation in detail, and the extent of the salt build up (**Fig.1**).

Figure 1: Sideview footage revealing perforations plugged by salts

With the advanced information provided by PerforationVA, the operator was able to select the most effective method to remove the salt, and restore the injectivity performance of the well.

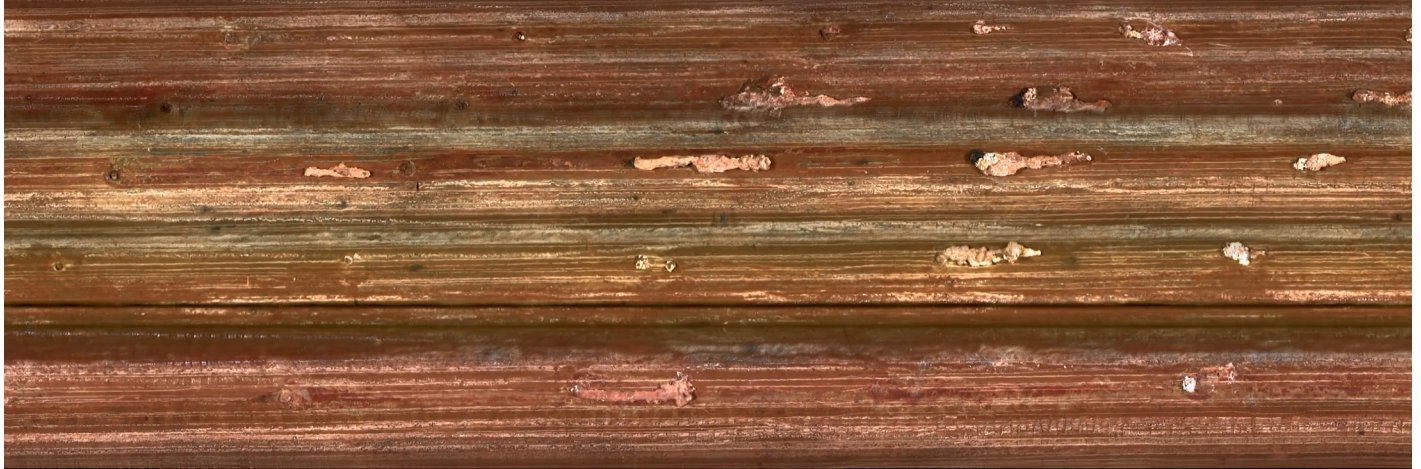
Figure 2: 360 degree mosaic image of plugged perforations

Through a process known as ‘mosaicing’, a continuous 360 degree view of the area of interest was created, helping to visualise the perforations and salt deposits (Fig.2). Further image processing enabled the generation of a 3D view of the area of interest. This advanced visual information also confirmed that no other anomalies were present within the well (Fig.3).

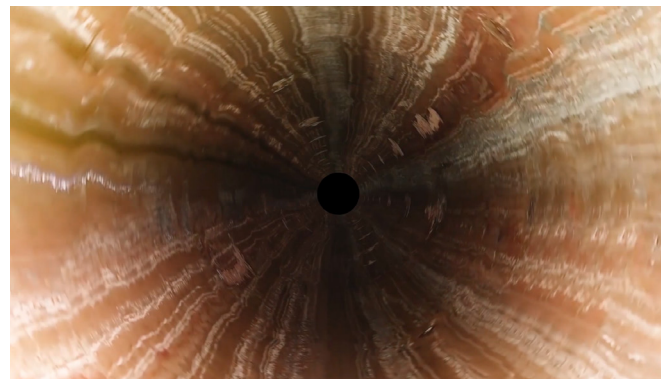
Figure 3: 3D view of area of interest

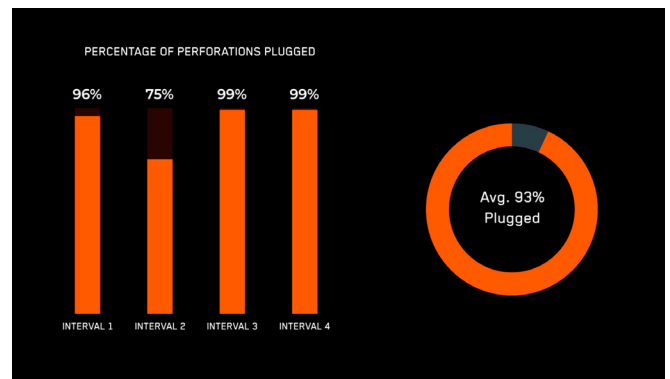
To complete the PerforationVA process an EV analyst examined the video data and evaluated the extent of the plugging within each individual perforation. Results revealed that on average, over 93% of all perforations across the 4 intervals were plugged by salt (Fig.4).

Figure 4: Quantified data revealing avg. 93% of perforations plugged by salts
