PerforationVA

OPTIMIZING PERFORATION PRODUCTIVITY

A Canadian operator experienced declining injectivity performance in a Carbon Dioxide disposal well. Injection log data suggested that a number of perforations may have become plugged. Possible explanations included salt precipitation, scaling or a build up of injected solids. With multiple possible scenarios, the operator needed a clear and detailed understanding of the situation downhole, to select and execute the most appropriate remedial action.

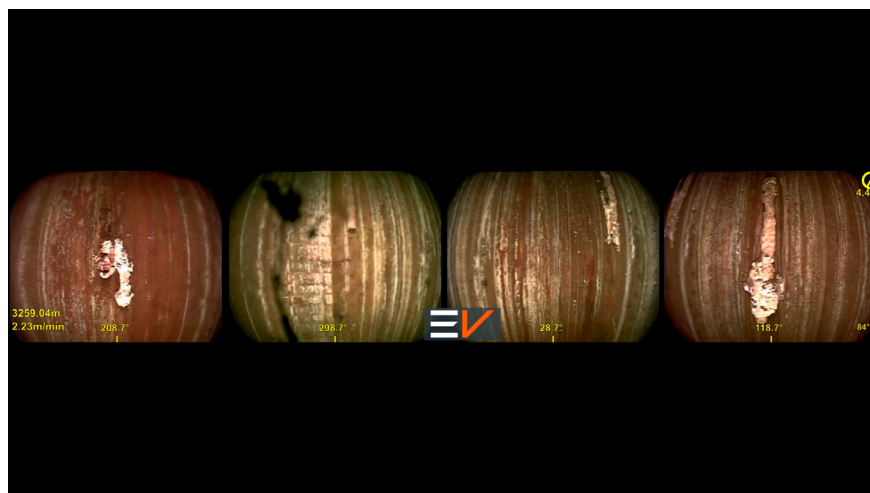
The camera was run in hole to a depth of 3200m, where the detailed real-time video footage confirmed the presence of salts across all of the perforated intervals. The 360-degree perspective provided by the four sideview cameras revealed the condition of each perforation in detail, and the extent of the salt build up (**Fig. 1**).

Figure 1: Sideview footage revealing perforations plugged by salts

With the advanced information provided by PerforationVA, the operator was able to select the most effective method to remove the salt, and restore the injectivity performance of the well.

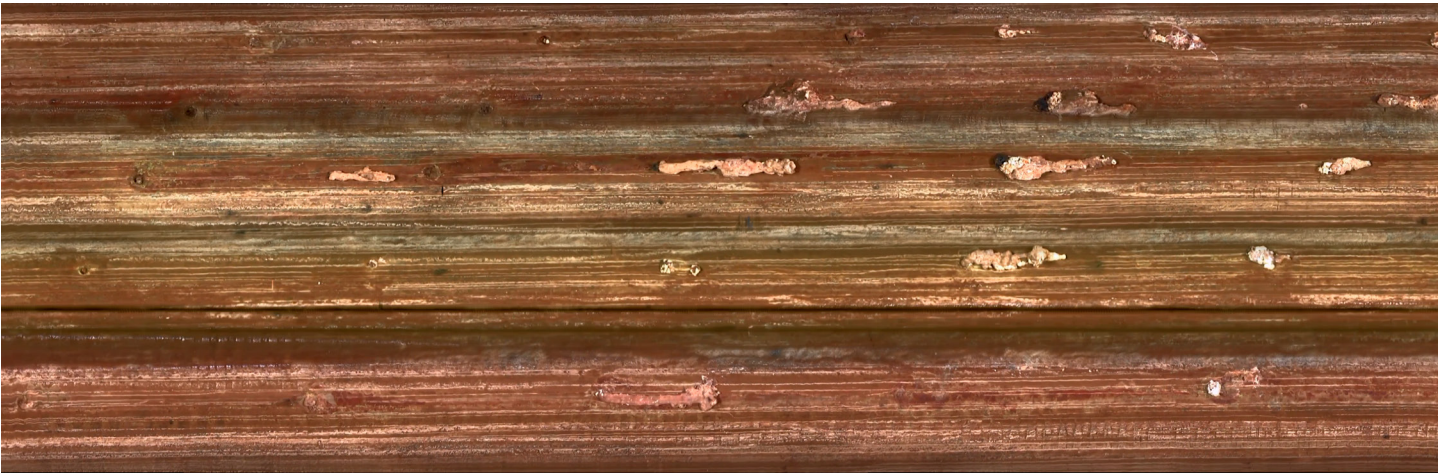
Figure 2: 360 degree mosaic image of plugged perforations

Through a process known as ‘mosaicing’, a continuous 360 degree view of the area of interest was created, helping to visualise the perforations and salt deposits (Fig.2). Further image processing enabled the generation of a 3D view of the area of interest. This advanced visual information also confirmed that no other anomalies were present within the well (Fig.3).

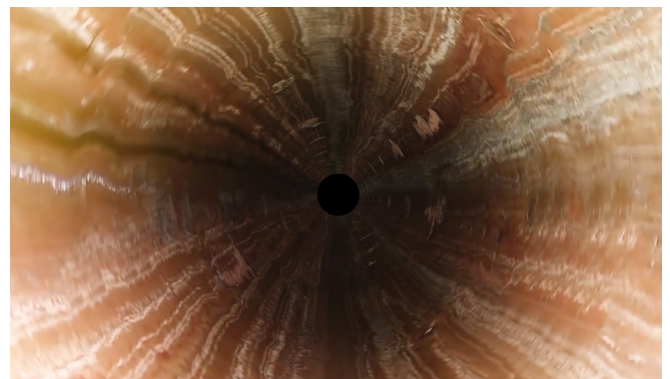
Figure 3: 3D view of area of interest

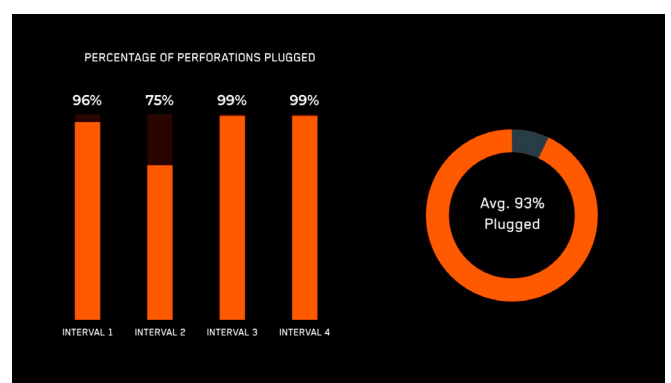
To complete the PerforationVA process an EV analyst examined the video data and evaluated the extent of the plugging within each individual perforation. Results revealed that on average, over 93% of all perforations across the 4 intervals were plugged by salt (Fig.4).

Figure 4: Quantified data revealing avg. 93% of perforations plugged by salts
