ValveVA

INTEGRITY RESTORED WITH VISUAL ANALYTICS

CONTROL LINE LEAK

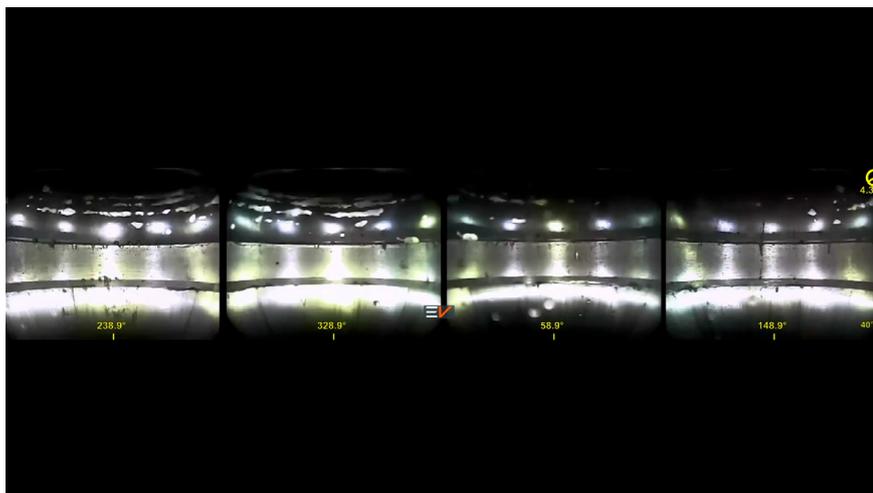
The camera was run to a depth of 600 feet where the 360 degree footage confirmed the flow tube to be in the open position. The footage confirmed there were no signs of damage, build up of deposits or other factors that would compromise the installation of the insert valve (**Fig.1**).

Figure 1: Sideview footage confirming flow tube in the open position

Armed with the quantified information provided by ValveVA, the operator successfully performed a rig-less intervention to install a wireline retrievable safety valve, resulting in rapid restoration of safe production and avoidance of a costly workover.

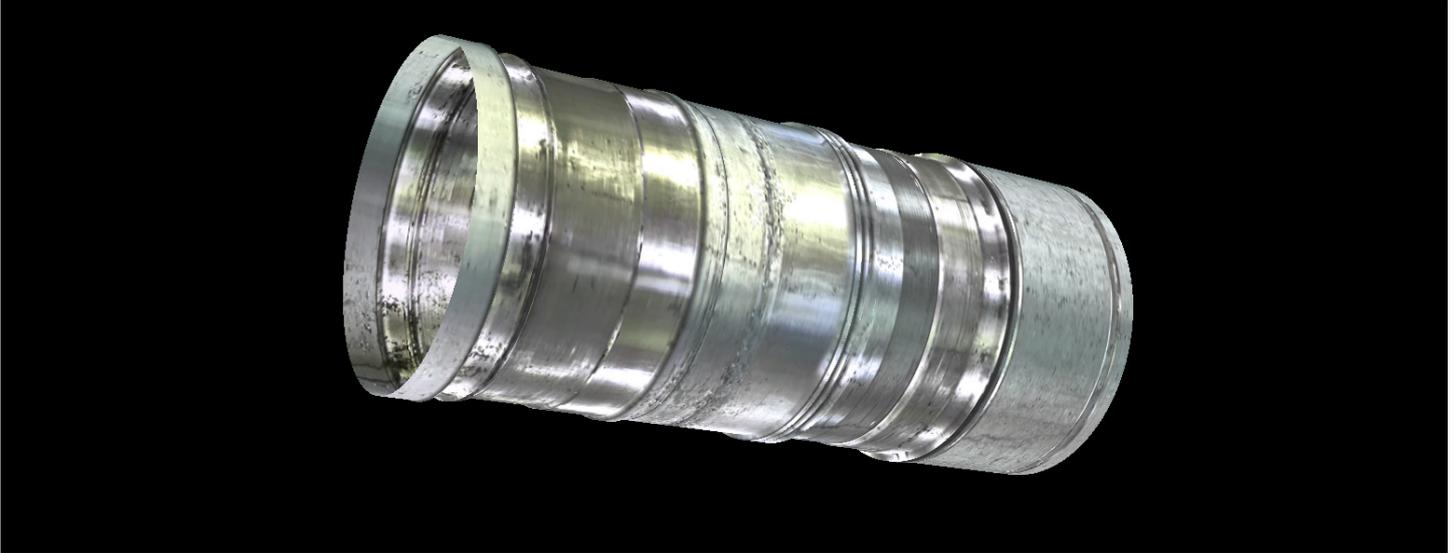
Figure 2: interactive 3D model ,enabling direct comparison of the acquired data with engineering drawings of the assembly.

EV's proprietary Visual Analytics processes were then applied to create a fully interactive 3-Dimensional model of the area of interest, enabling direct comparison of the acquired data with engineering drawings of the assembly (Fig.2).

Visual correlation of key components, and the measurement of their geometries, provided conclusive proof that the flow tube was fully locked open and that it was safe to proceed with installation of the insert valve.
