ValveVA

INTEGRITY RESTORED WITH VISUAL ANALYTICS

CONTROL LINE LEAK

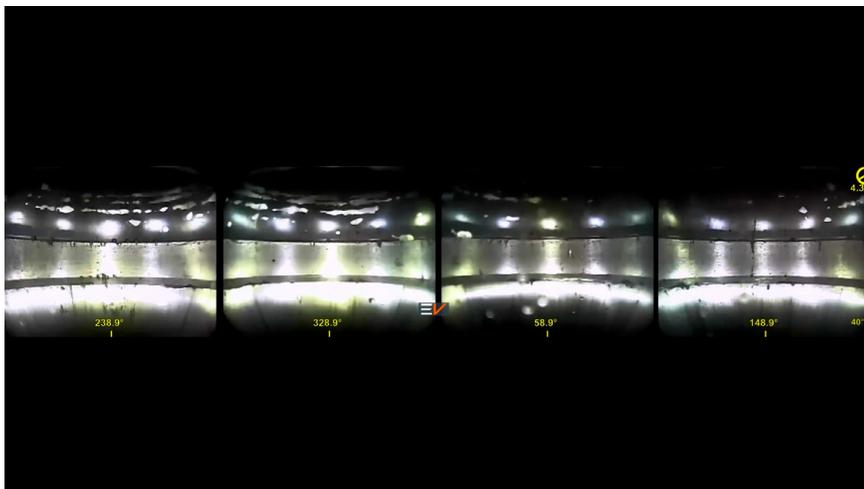
The camera was run to a depth of 600 feet where the 360 degree footage confirmed the flow tube to be in the open position. The footage confirmed there were no signs of damage, build up of deposits or other factors that would compromise the installation of the insert valve (**Fig.1**).

Figure 1: Sideview footage confirming flow tube in the open position

The 360 degree footage confirmed the flow tube to be in the open position. The footage also confirmed there were no signs of damage, build up of deposits or other factors that would compromise the installation of the insert valve (**Fig.1**). EV's proprietary Visual Analytics processes were applied to create a fully interactive 3-Dimensional model of the area of interest, enabling direct comparison of the acquired data with engineering drawings of the assembly. (**Fig.2**) Having provided conclusive proof that the flow tube was fully locked open, the operator successfully performed a rig-less intervention to install a wireline retrievable safety valve, resulting in rapid restoration of safe production and avoidance of a costly workover.

Armed with the quantified information provided by ValveVA, the operator successfully performed a rig-less intervention to install a wireline retrievable safety valve, resulting in rapid restoration of safe production and avoidance of a costly workover.

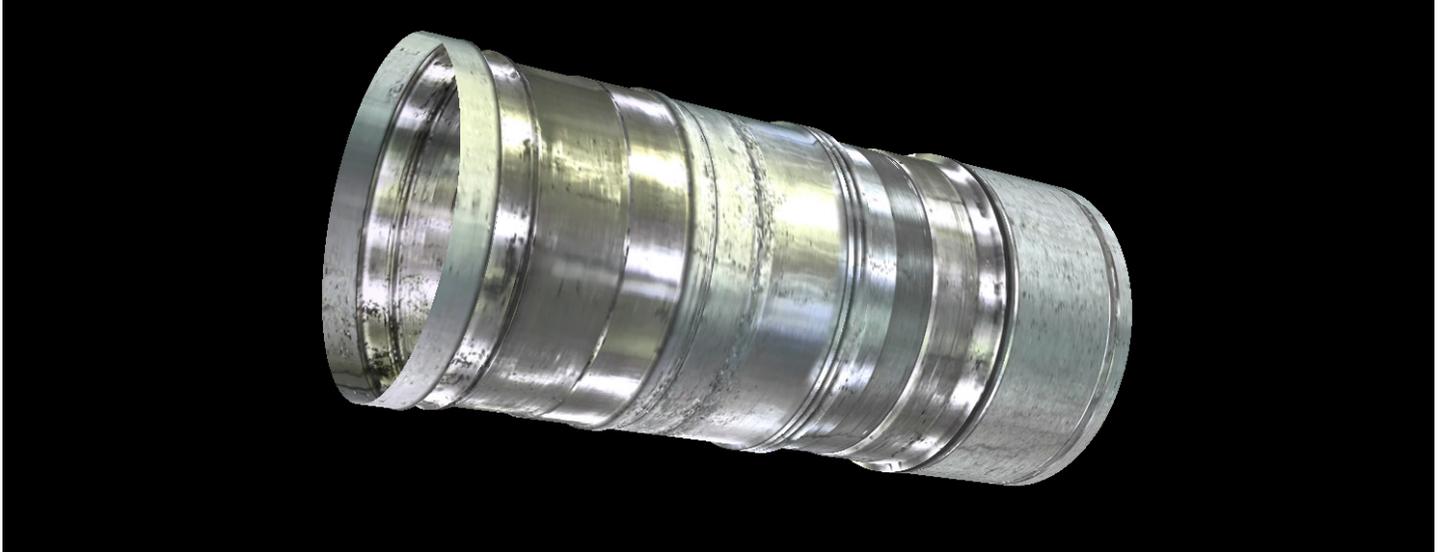
Figure 2: interactive 3D model enabling direct comparison of the acquired data with engineering drawings of the assembly.

EV's proprietary Visual Analytics processes were then applied to create a fully interactive 3-Dimensional model of the area of interest, enabling direct comparison of the acquired data with engineering drawings of the assembly (**Fig.2**).

Visual correlation of key components, and the measurement of their geometries, provided conclusive proof that the flow tube was fully locked open and that it was safe to proceed with installation of the insert valve.

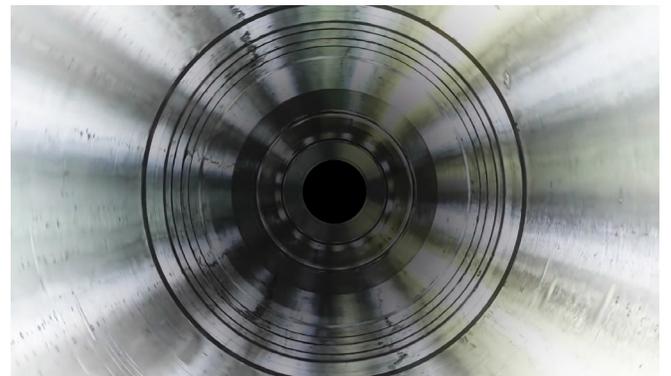
Figure 3: 3D fly-through visualization
