## RestrictionVA

# COMPLEX RESTRICTION IN MULTI-LATERAL WELL

### WELLBORE RESTRICTIONS

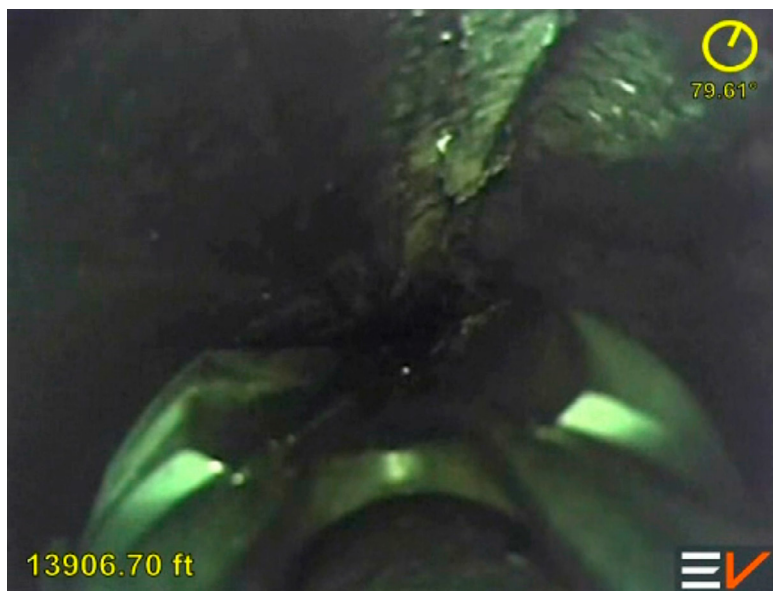
The well was bull headed with Nitrogen to displace opaque wellbore fluids, create a clear viewing environment, and to cool down the well. The camera was run downhole to the target depth, where the detailed real-time footage revealed the smart completion window to be mis-aligned with the outer milled out casing window (**Fig.1**).

Figure 1: Confirmation of completion window misalignment

With the quantified information provided by RestrictionVA, and a clear visual understanding of the restriction provided, the operator was able to redesign the completion orientation mechanism and deployment methodology on future nearby wells as a preventative measure.

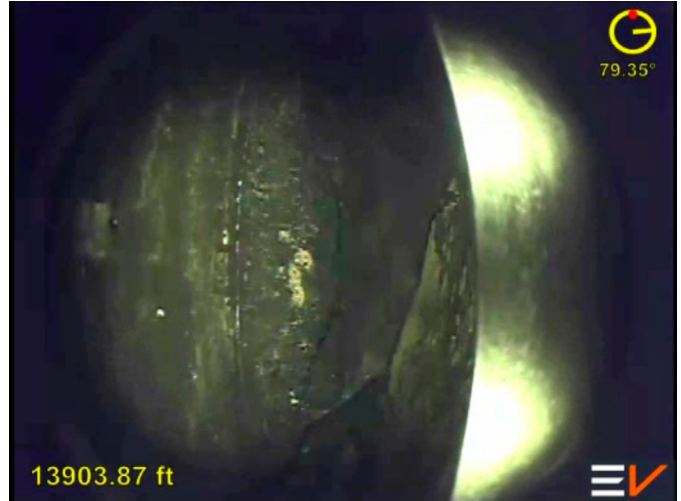
The detailed sideview footage identified the casing overlap in more detail, revealing the extent of the restricted access (**Fig.2**).

Figure 2: Sideview image of casing overlap

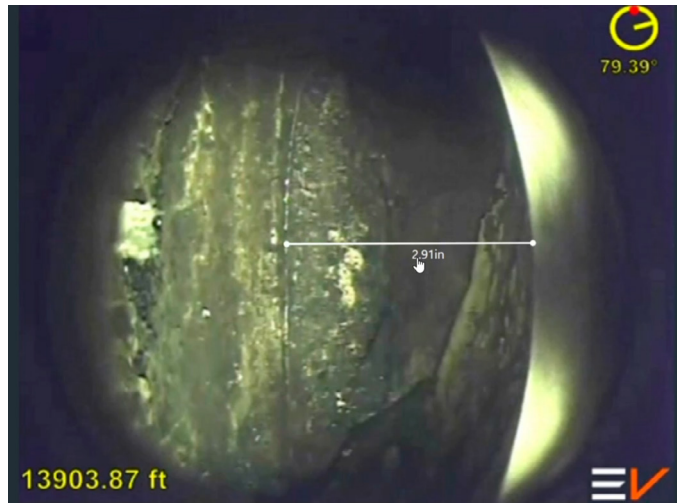
Using EV's Integrated Dimensioning software, an EV analyst provided detailed and accurate measurements of the smart casing window respective to the outer casing window, providing concise confirmation of the restricted access and extent of misalignment (**Fig.3**).

Figure 3: Measurements confirming extent of casing overlap
