RestrictionVA

COMPLEX RESTRICTION IN MULTI-LATERAL WELL

WELLBORE RESTRICTIONS

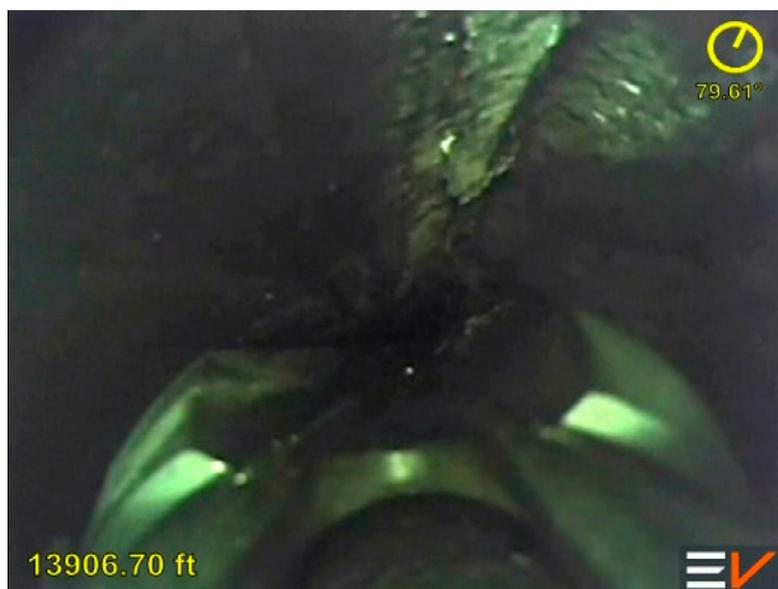
The well was bull headed with Nitrogen to displace opaque wellbore fluids, create a clear viewing environment, and to cool down the well. The camera was run downhole to the target depth, where the detailed real-time footage revealed the smart completion window to be mis-aligned with the outer milled out casing window (**Fig.1**).

Figure 1: Confirmation of completion window misalignment

With the quantified information provided by RestrictionVA, and a clear visual understanding of the restriction provided, the operator was able to redesign the completion orientation mechanism and deployment methodology on future nearby wells as a preventative measure.

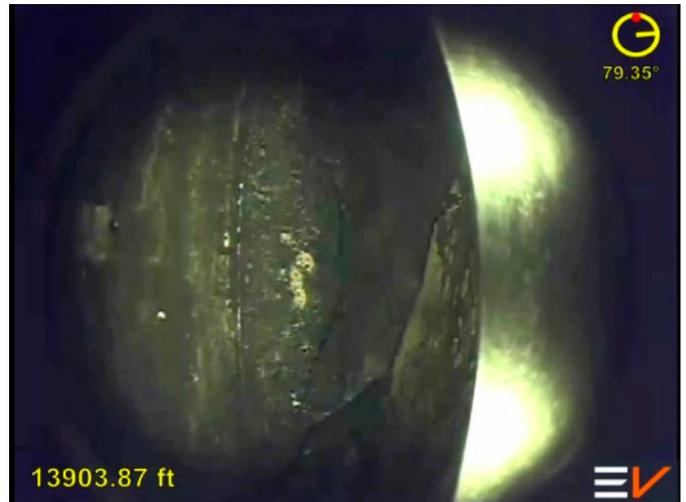
The detailed sideview footage identified the casing overlap in more detail, revealing the extent of the restricted access (**Fig.2**).

Figure 2: Sideview image of casing overlap

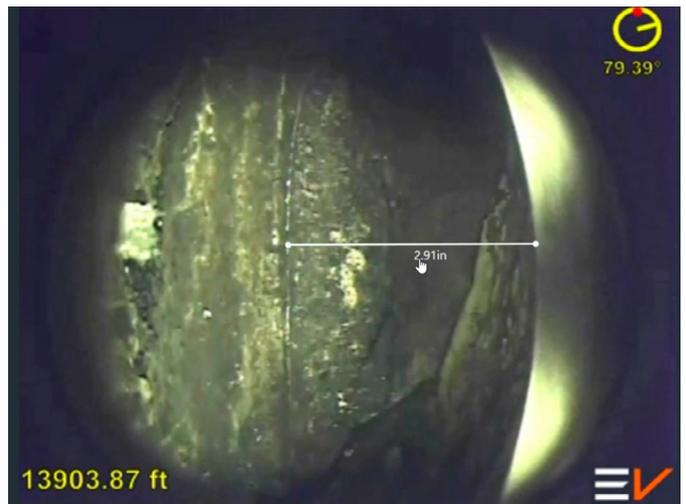
Using EV's Integrated Dimensioning software, an EV analyst provided detailed and accurate measurements of the smart casing window respective to the outer casing window, providing concise confirmation of the restricted access and extent of misalignment (**Fig.3**).

Figure 3: Measurements confirming extent of casing overlap
