RestrictionVA

IDENTIFYING AND OVERCOMING A CASING BREACH

EV's Integrated Video Caliper (IVC) tool incorporates qualitative & quantitative measurements to identify the root cause of restricted wellbore access

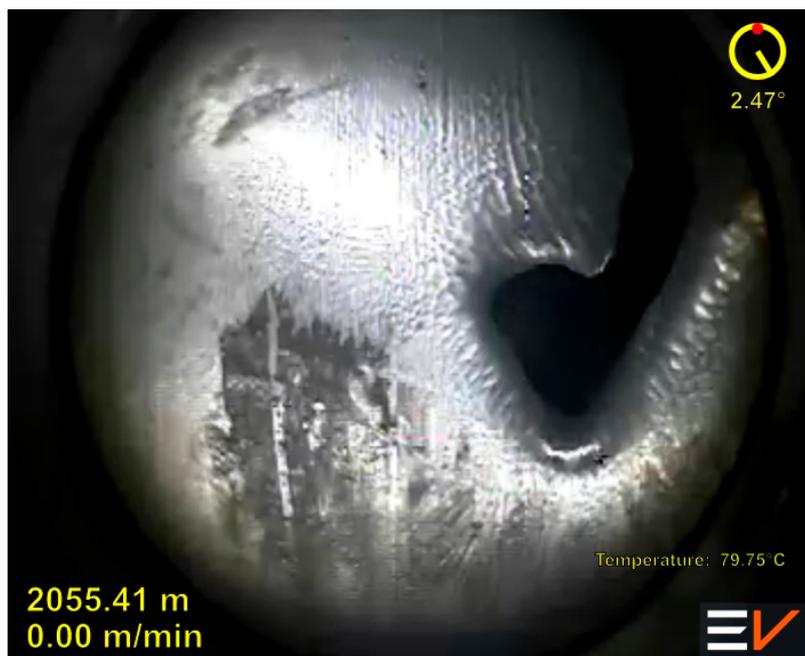
Upon reaching 2050 metres, the cause of the hold-up was immediately identified. A full breach of the casing was located just above a connection. The sideview footage revealed the extent of the damage in detail, and that the perimeter of the split was evidently eroded by proppant flow into the annulus (**Fig.1**). While it turned out not to be a casing collapse, this breach is evidently causing loss of pump-down pressure and restricting access to the well.

Figure 1: Sideview footage of casing breach

With the quantified information provided by RestrictionVA, and a clear visual understanding of the restriction provided, the operator was able to patch the casing breach on the next run, allowing them to successfully complete the frac job and put the well onto production.

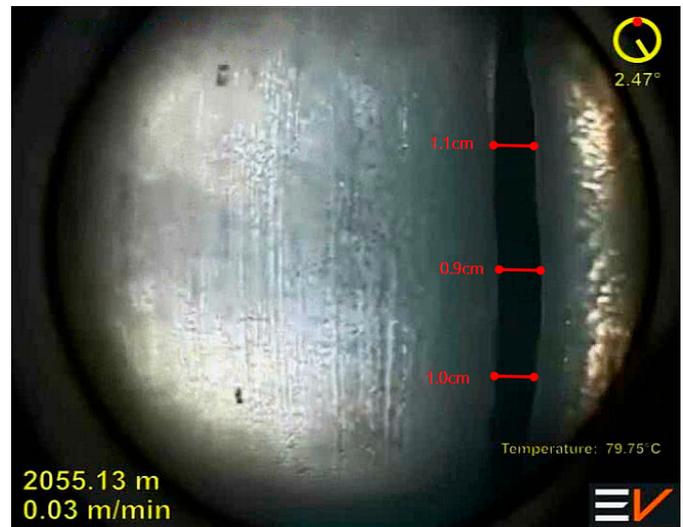
Using EV's Integrated Dimensioning software, an EV analyst provided detailed and accurate measurements to determine the size of the split. These measurements revealed the split was approximately 1cm wide and 18cm long (**Fig.2**). The visual assessment was confirmed by detailed analysis of the caliper data. Additional 3D views were produced to help visualize the casing split in more detail.

Figure 2: Measurements revealing extent of casing split

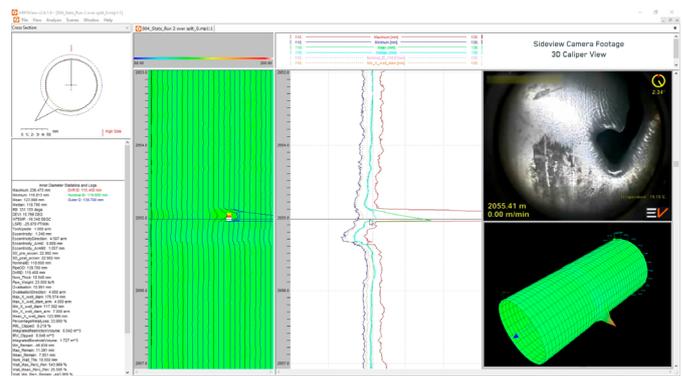
Figure 3: Combined video and caliper view
